8 (1)
AD 73767
MISCELLANEOUS PAPER NO. 4-886

EVALUATION OF THREE-PIECE AM2 ALUMINUM LANDING MAT

Naval Air Engineering Center
Philadelphia, Pennsylvania

U. S. Army Engineer Waterways Experiment Station
CORPS OF ENGINEERS
Vicksburg, Mississippi

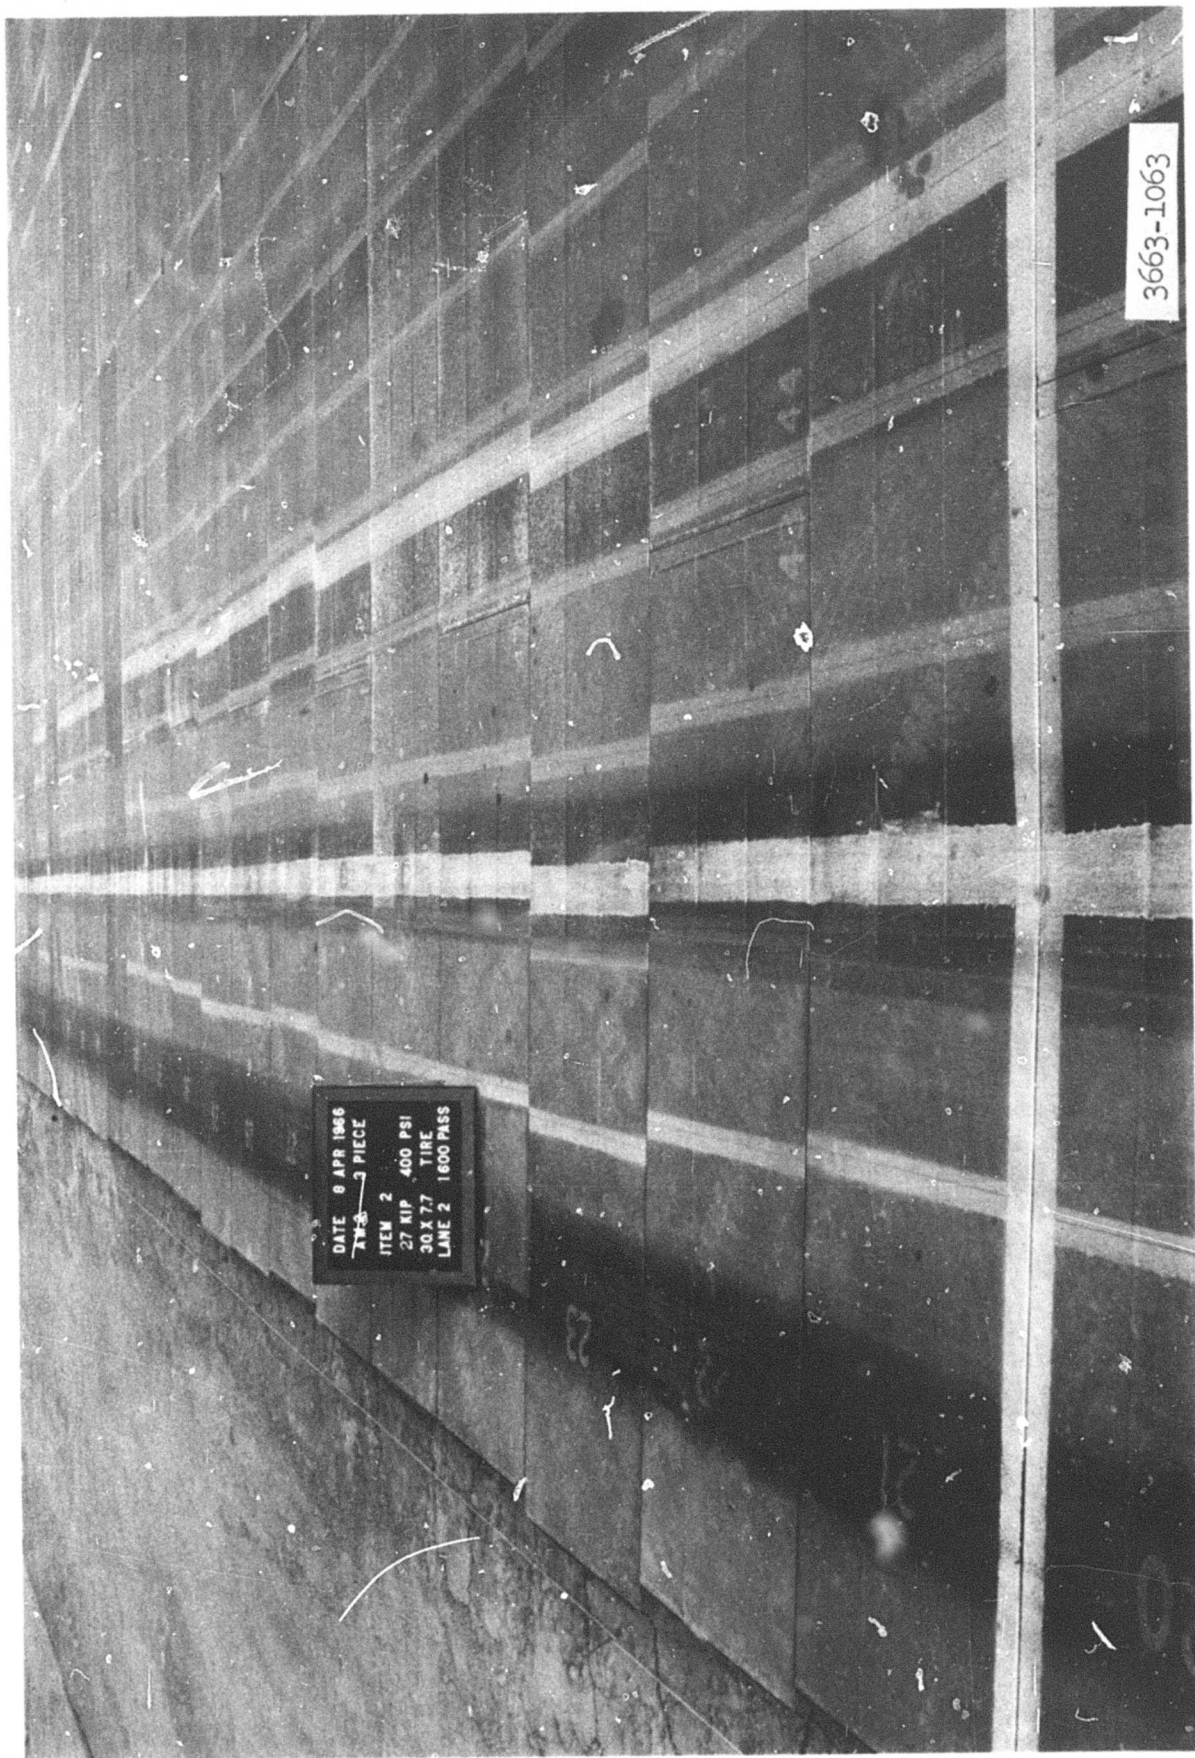
29. Item 2. A general view of item 2 prior to traffic is shown in photograph 22. This item withstood trafficking without significant visible effects until 1320 passes, at which time it was observed that eight planks had slightly dished extrusions. At 1520 passes, a large crack had occurred in the longitudinal weld on the south side of plank 61 and a skin tear at the same relative position on plank 77 (photograph 23). Both breaks appeared suddenly and as a result of core damage. After 1600 passes, traffic was stopped. At this time, in addition to planks 61 and 77, there were 14 areas of apparent core damage in the item. In about half of the damaged planks failure appeared to be imminent, and the item was generally in poor condition (photograph 24).

Photograph 24. Item 2, lane 2, after 1600 passes

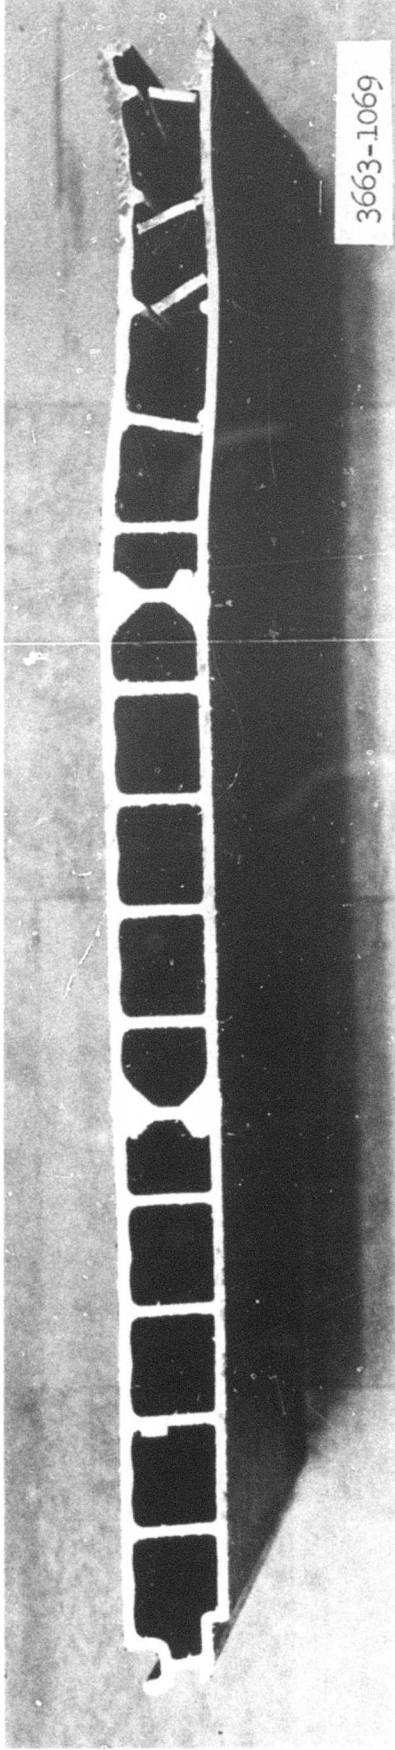
38. All core failures in lane 1 were located in an area of the plank adjacent to the joint of the preceding run and were caused by joint failure and subsequent deflection which resulted in the core's sustaining the impact of the load wheel. As can be seen in photograph 29, the core failure was limited to the extrusion nearest the joint. It should be noted that all failures and breaks which occurred during uniform-coverage traffic were located at or adjacent to an end joint.

Photograph 29. Cut section of mat from uniform-coverage traffic test, showing core failure. The failed core was located directly adjacent to the joint in the preceding run

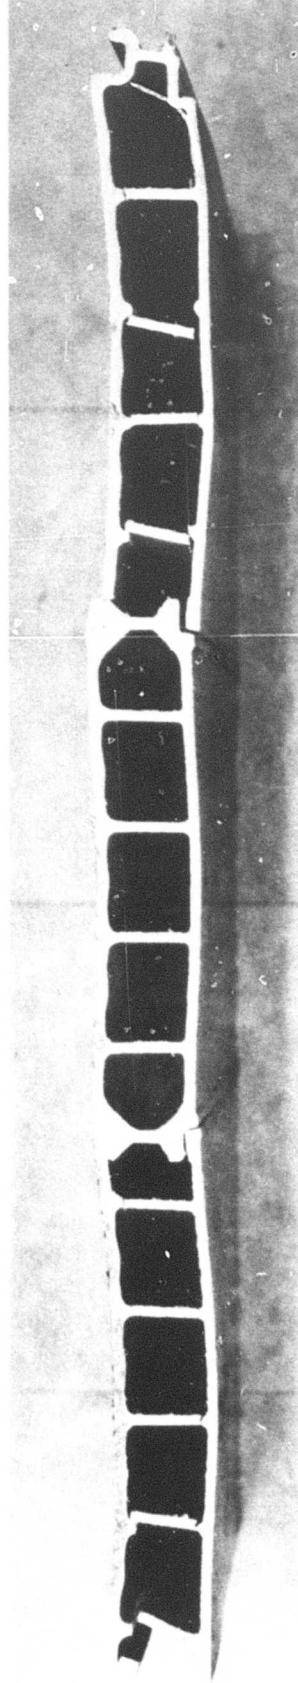
43. All mat breakage was the result of initial core failure in one or more of the individual extrusions making up a plank, particularly the extrusions with the side connectors (photograph 30). The six core failures in item 1 occurred in extrusions on the south side of the plank, which were the extrusions with the male side connectors. Of the 29 areas of apparent core damage in the test lane, 16 occurred in extrusions having the male side connector, 7 were located in extrusions having the female side connector, and 6 occurred in the center extrusions. Of the planks that were considered failed during the test, the metal skin on top of each plank generally failed before the adjacent longitudinal weld (photograph 23). In item 1, there were six skin tears at failure versus three longitudinal weld cracks on top of the mat. However, longitudinal weld cracks were found on the bottom of eight planks when the mat was removed at the end of traffic. There was no indication of the period during which these cracks occurred. Since the single-path traffic lane was 2 ft from the closest line of end joints, obviously no end connectors were located in the traffic lane and, therefore, no end-connector failures occurred.

Photograph 30. Cut section of mat from single-line traffic lane showing core damage
